123 Apple Ln.

July 11th, 2018

Inspected by Desmond Thornton
Prepared for John Doe

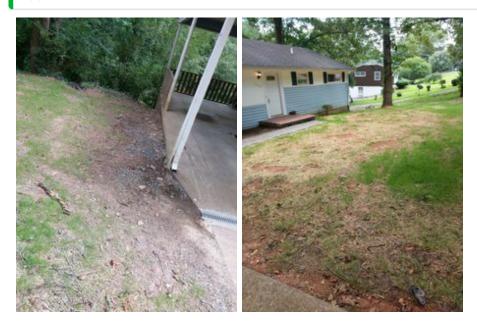
1.1 · GRADING CONDITIONS

Evidence indicates that the Grading of the soil near the foundation is in serviceable condition.

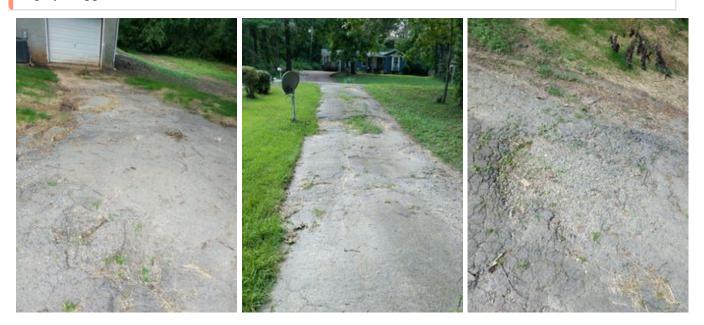
1.3 · DRIVEWAY CONDITIONS

Replacement of the secondary driveway is necessary.

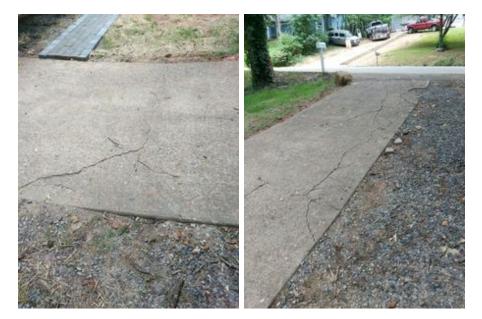
1.4 · DRIVEWAY CONDITIONS

The driveway appears to be approaching the end of its useful life. Typically, concrete lasts up to 30 years, while asphalt lasts up to 20 years. However, installers say driveways may need to be replaced sooner or last longer depending on upkeep.

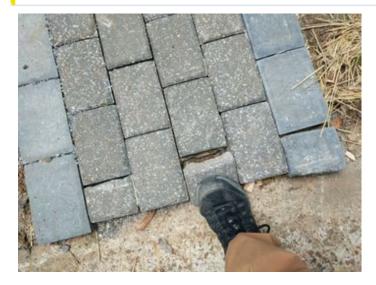
1.5 · SIDEWALK CONDITIONS

Loose material noted on the sidewalk.

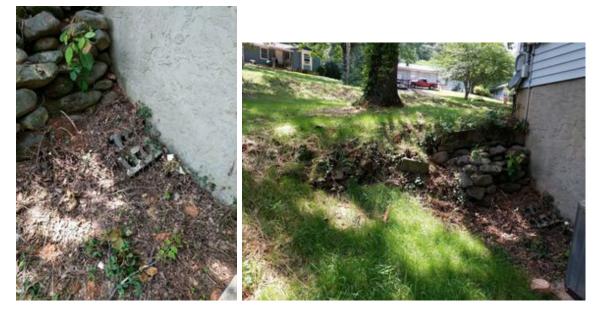
1.6 · RETAINING WALL CONDITIONS

The existing retaining wall has been overrun by water and soil erosion. Recommend replacing the existing retaining wall.

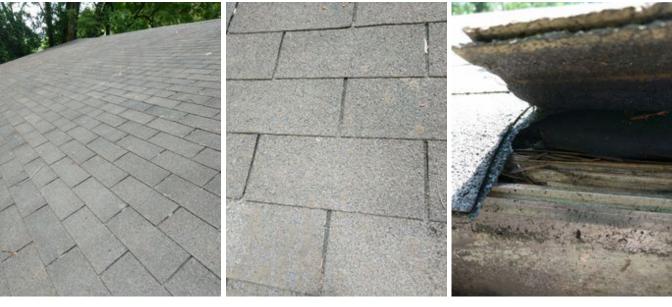
3.1 · ROOF COVERING CONDITION

The roof showed advanced signs of aging and deterioration. This condition can indicate imminent leakage. Replacement is recommended. Recommend further evaluation by a qualified roofing contractor. The inspector cannot offer an opinion as to whether the roof leaks today unless it is moderately raining at the time of inspection. Client should obtain full disclosure / history information from the seller prior to close.

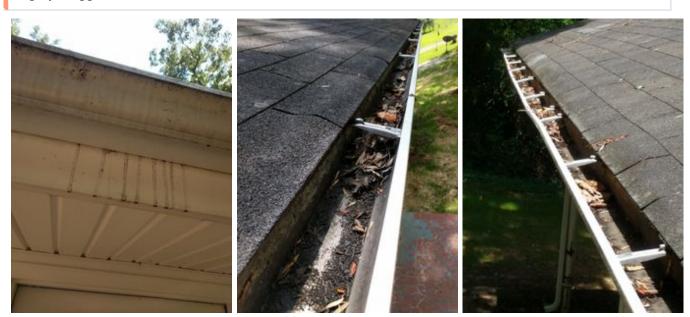
3.4 · GUTTER & DOWNSPOUT CONDITIONS

Clean gutters as maintenance if cleaned out many issue can arise such as foundation cracks, water in the basement/crawlspace, water damage to different areas.

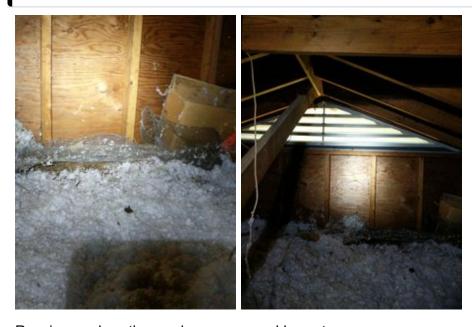
3.7 · ATTIC CONDITIONS

Repair or replace the mesh screen on gable vents.

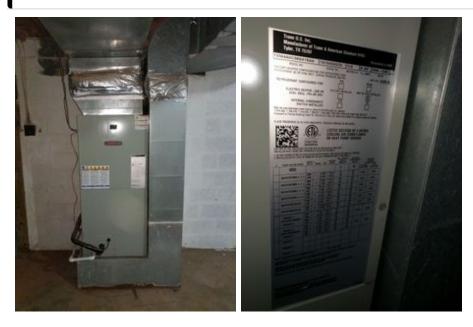
5.5 · UNIT CONDITIONS

Out of season. Recommend bi-annual maintenance on the HVAC system.

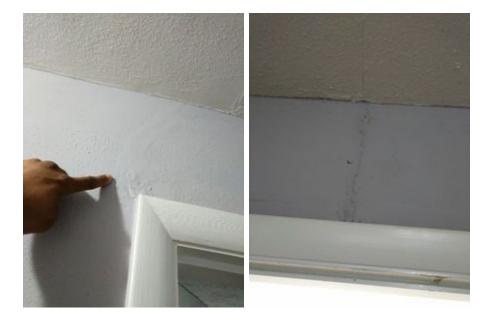
6.2 · WALL CONDITIONS

Evidence of repairs.

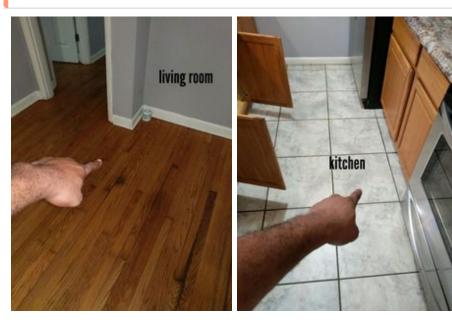
6.5 · FLOOR CONDITIONS

Original subfloor in the home. Minor was sagging felt during the inspection due to age. in the future recommend replacing when remodeling the floor area.

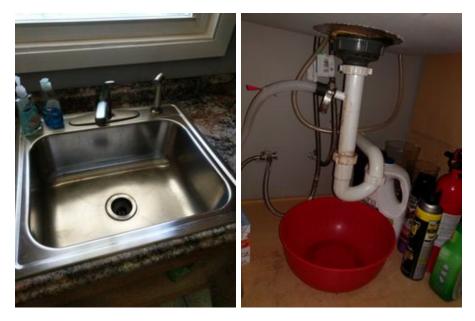
7.8 · SINK PLUMBING CONDITIONS

The drainpipes under the sink show signs of a past leak. This may need attention.

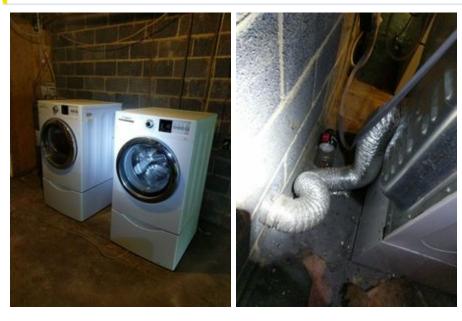
9.1 · LAUNDRY ROOM CONDITIONS

Shorten the duct to the dryer vent.

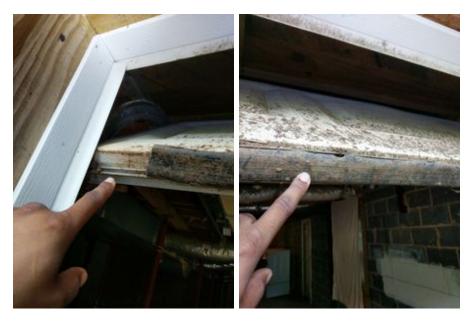
10.4 · VEHICLE DOOR CONDITIONS

Replace the bottom rubber / weatherstripping.

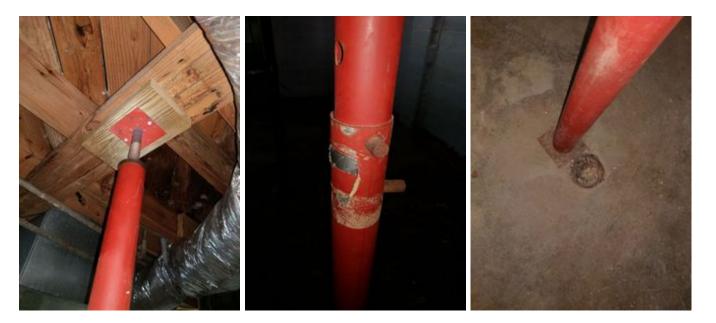
12.2 · FLOORING SUPPORT CONDITIONS

Unprofessional / temporary repairs were observed at . Recommend further evaluation and proper repairs by a qualified contractor.

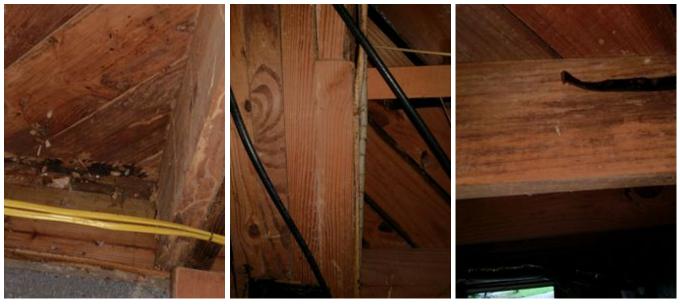
12.3 · FLOORING SUPPORT CONDITIONS

Evidence of wood damaging insects. Possibly a past infestation I would recommend a pest inspection to determine if it is active.

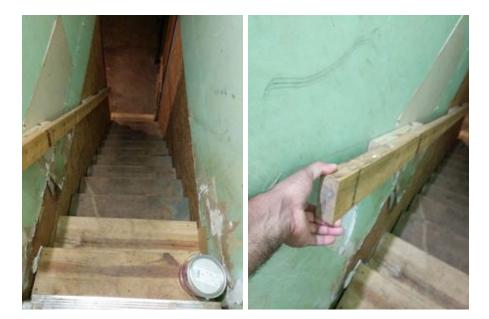
13.3 · BASEMENT STAIR CONDITIONS

The stair rail was a flat piece of wood. Considering the length of the steps, recommend installation of a separate rail that is easily graspable for increased safety.
